SEISMIC RISK EVALUATION

WATERFRONT PEARL CONDOMINIUMS

1260–1310 NW NAITO PARKWAY
PORTLAND, OREGON

APRIL 2014

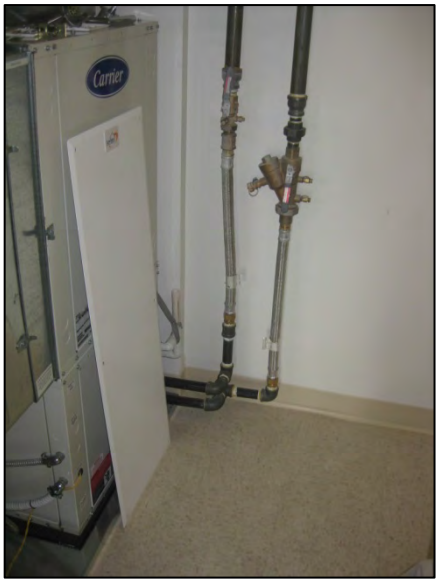
Photo A-6: In-unit—hot water heater
